# PROPERTY FLOOD RESILIENCE CASE STUDY: HEST BANK

## Overview

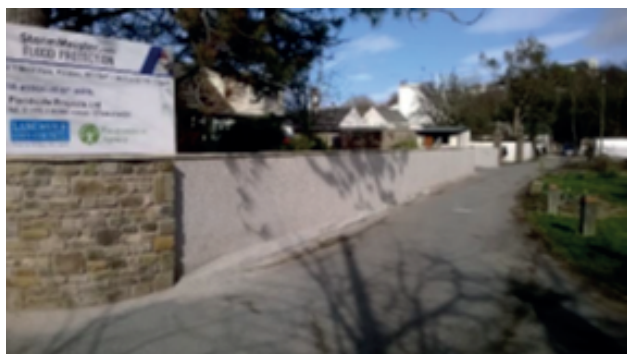
## New flood wall around properties

- 1x flood wall was constructed in front of two properties
- 9x flood gates installed.
- 1x non- return valve has been fitted to a drain
- 1x garage door barrier
- 5x surface water pumps were issued to compliment the measures.

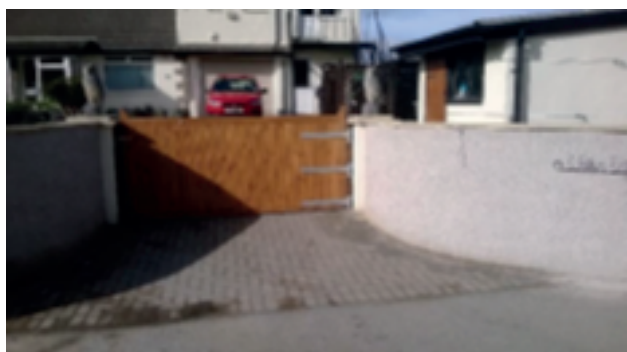
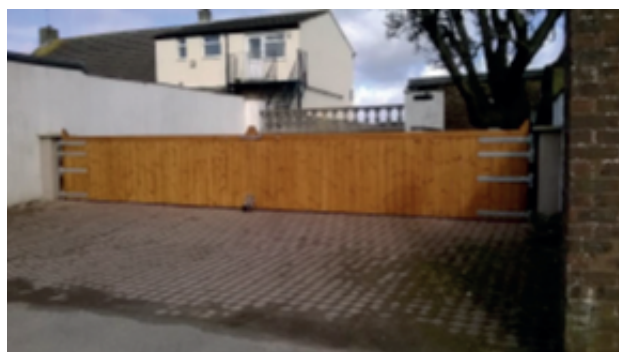
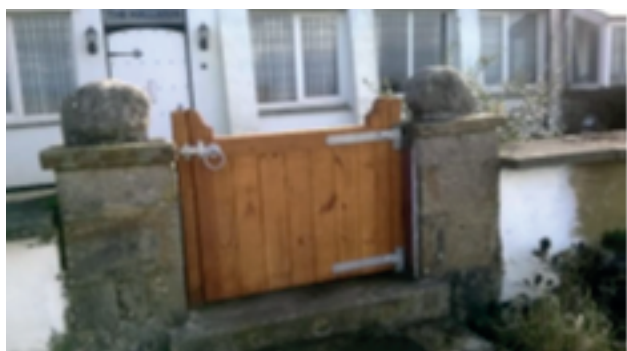
## Flood gates of various types

The residents are really pleased with the new flood measures and feel much safer now. It is now their responsibility to keep the gates maintained and to make sure that they are kept shut whenever they get a flood warning. The manufacturer provided a pack which details how the gates should be maintained.
