# PROPERTY FLOOD RESILIENCE CASE STUDY: HEST BANK

## OVERVIEW

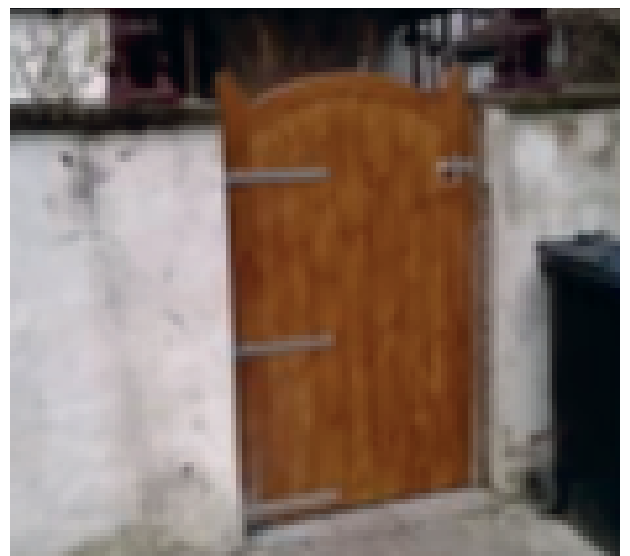
Image: The Flood Hub People

- 4x flood barriers
- 1x single flood door
- 1x double flood door

These measures formed a £40,000 scheme funded through a combination of DEFRA Repair and Renew Grant Funding which was made available to properties which flooded during 2013/14 and Environment Agency Flood Defence Grant in Aid funding.

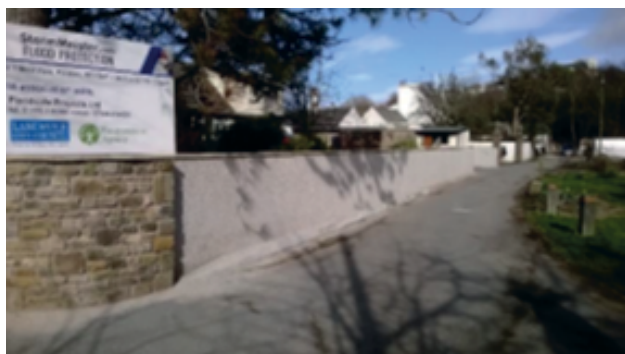
## NEW FLOOD WALL AROUND PROPERTIES

- 1x flood wall was constructed in front of two properties
- 9x flood gates installed.
- 1x non- return valve has been fitted to a drain
- 1x garage door barrier
- 5x surface water pumps were issued to compliment the measures.

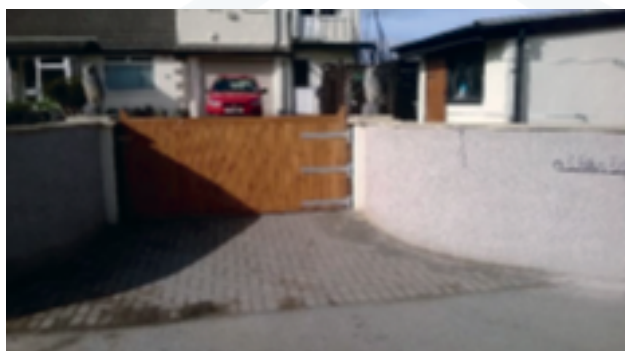
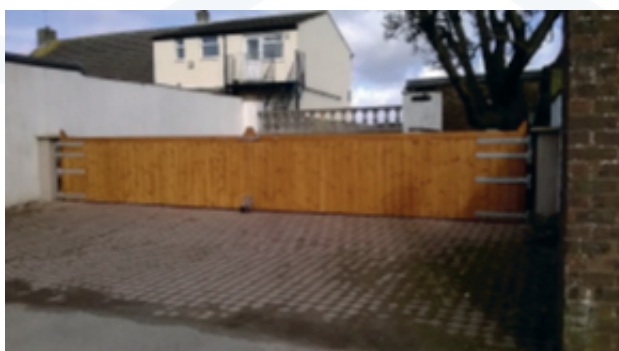
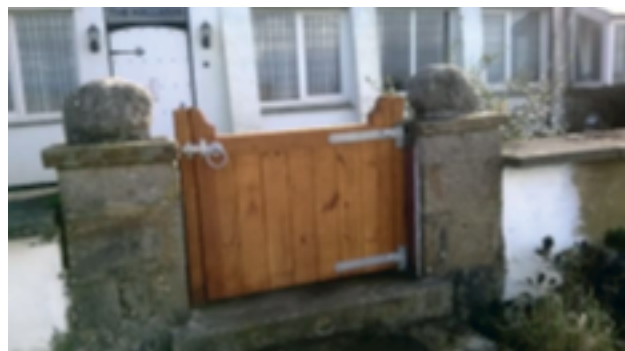
## FLOOD GATES OF VARIOUS TYPES

The residents are really pleased with the new flood measures and feel much safer now. It is now their responsibility to keep the gates maintained and to make sure that they are kept shut whenever they get a flood warning. The manufacturer provided a pack which details how the gates should be maintained.
